12/18/2021 (trail construction began 12/7/2021)

12/18/2021 (approx. 11 days after trail excavation began on 12/7/2021)

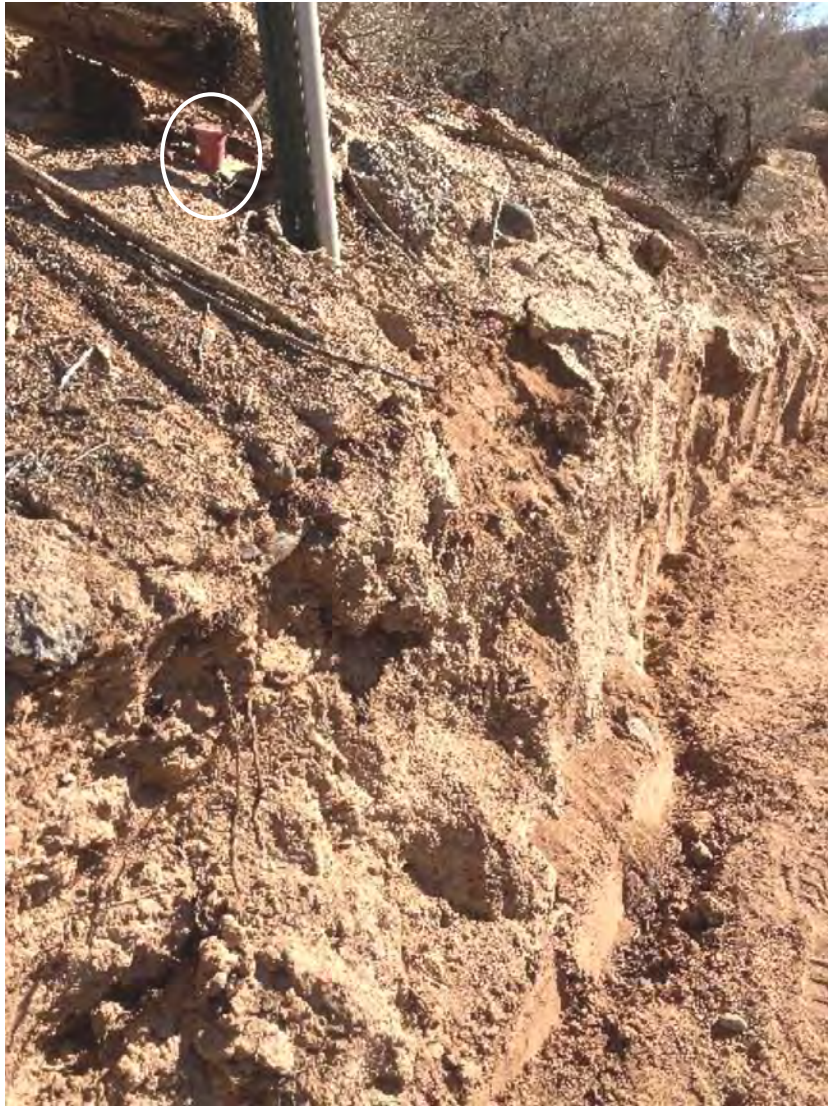
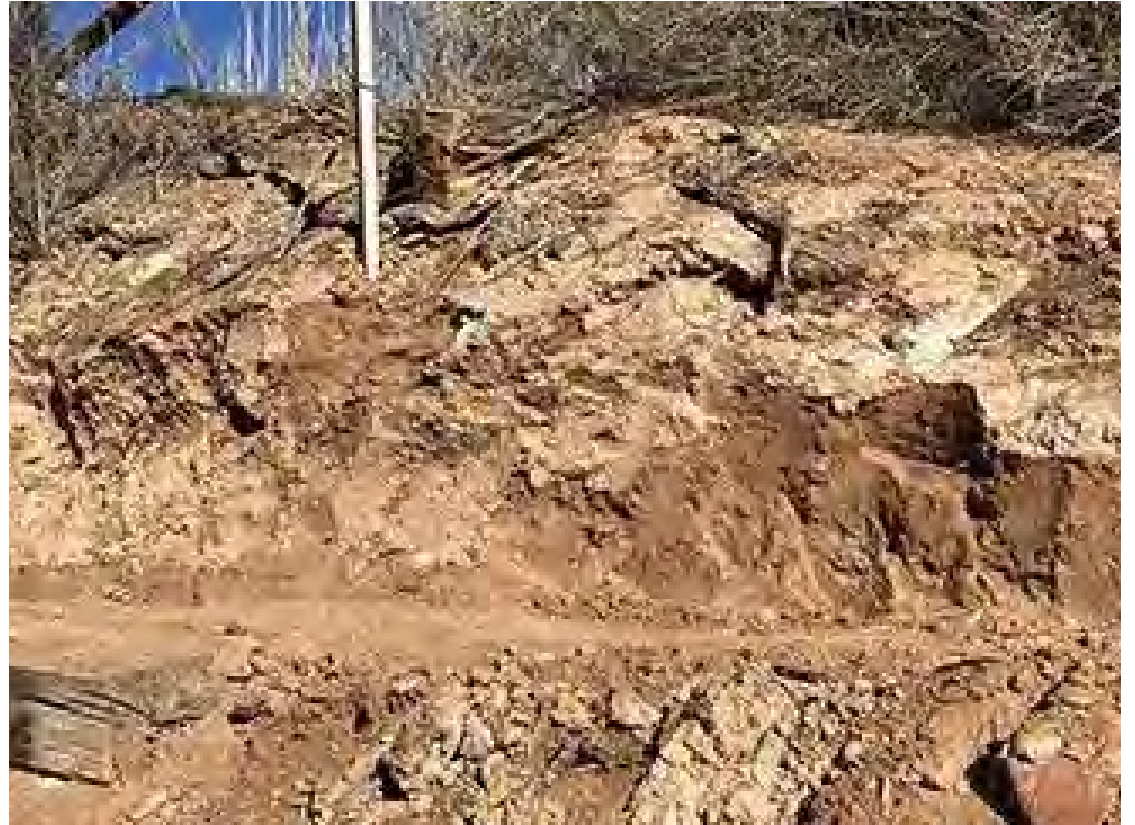
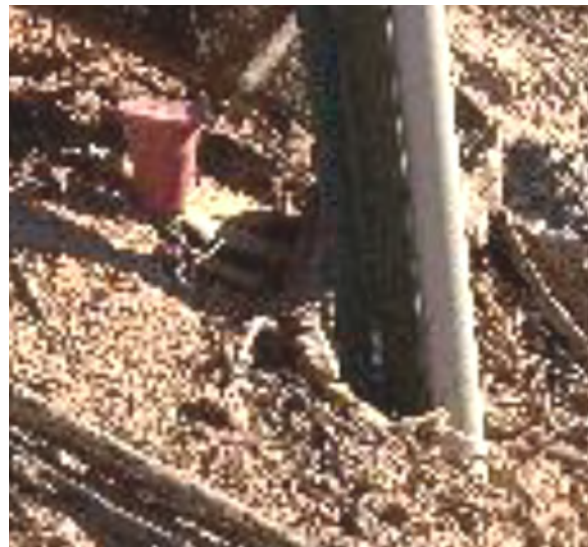
Soil almost reaches bottom of red cap on Burns SW corner pin and lower end of white marker pipe is embedded in soil

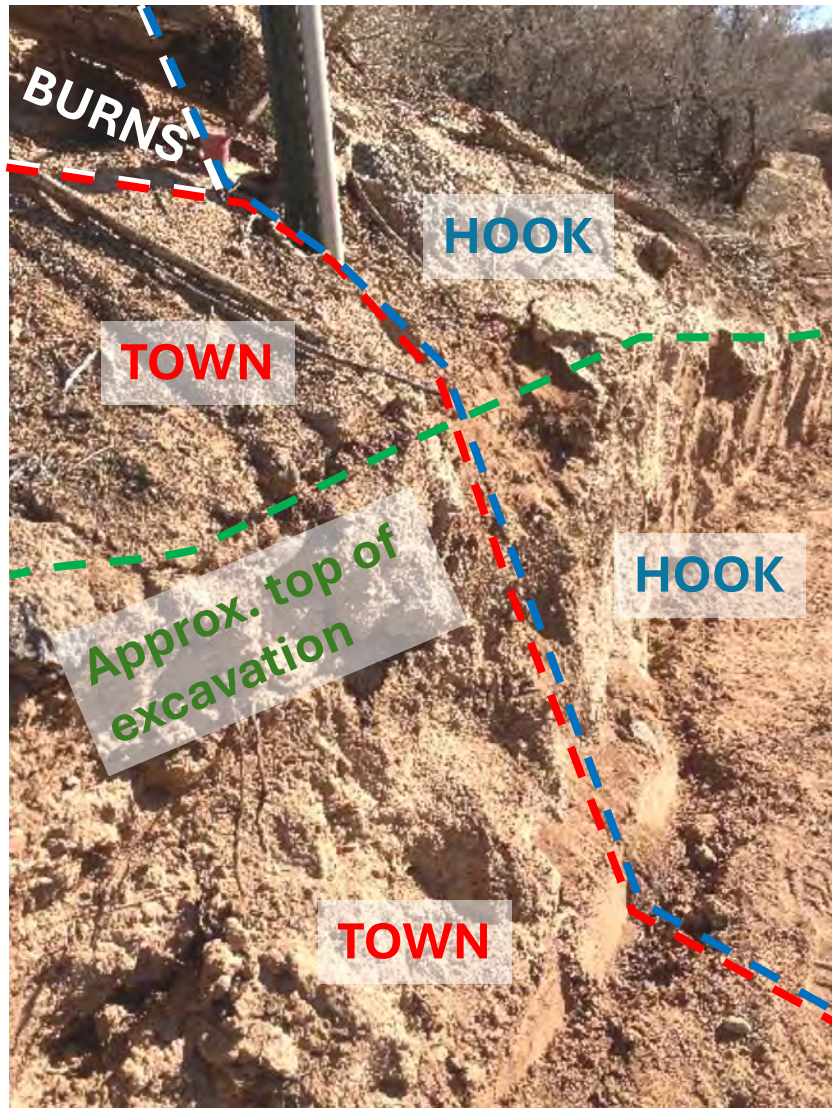
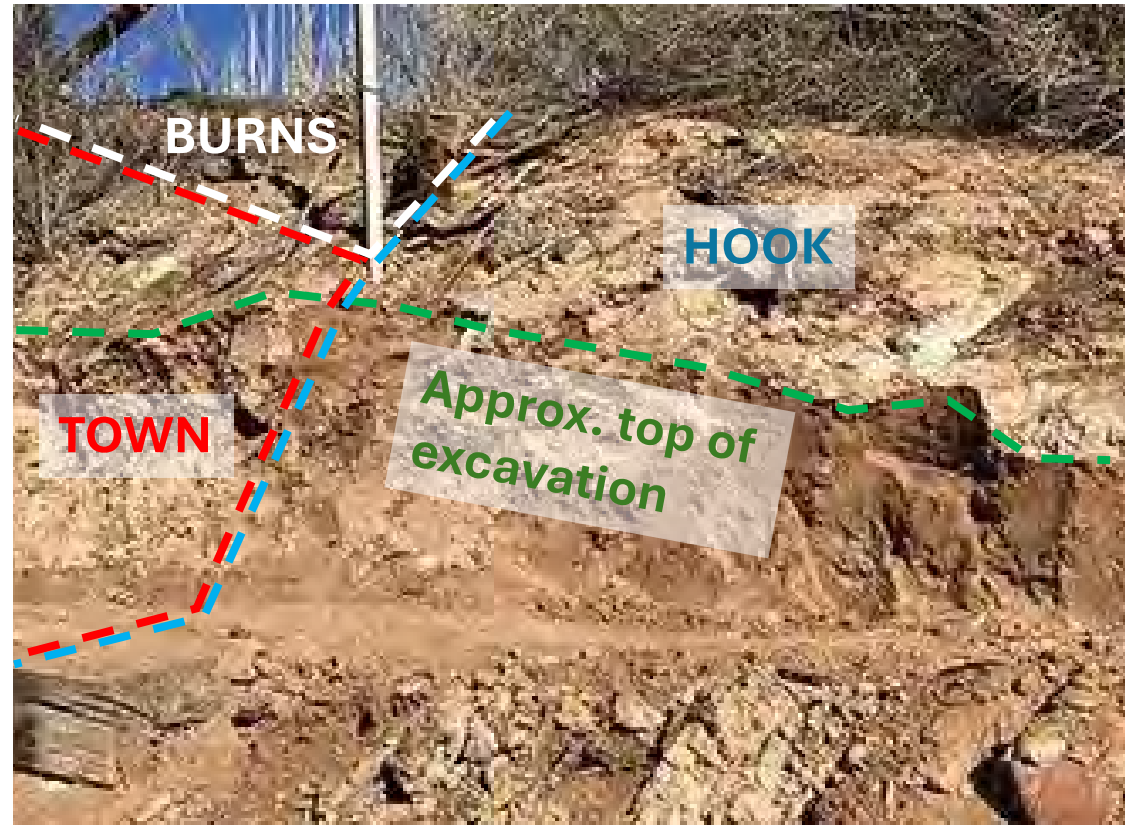
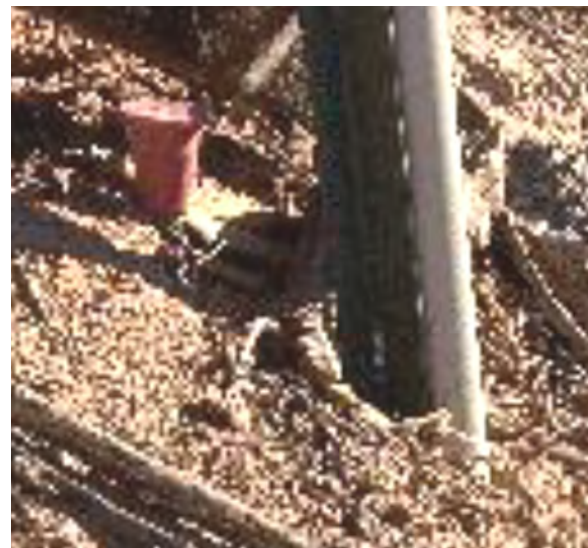
Excavation for trail created near-vertical slope into town and Hook land, very close to Burns SW corner stake. Before excavation, slope of land surface in excavated area was approx. similar to that above top of cut. Slope was fairly smooth in both areas, not gullied.

Soil almost reaches bottom of red cap on Burns SW corner pin and lower end of white pipe is embedded in soil

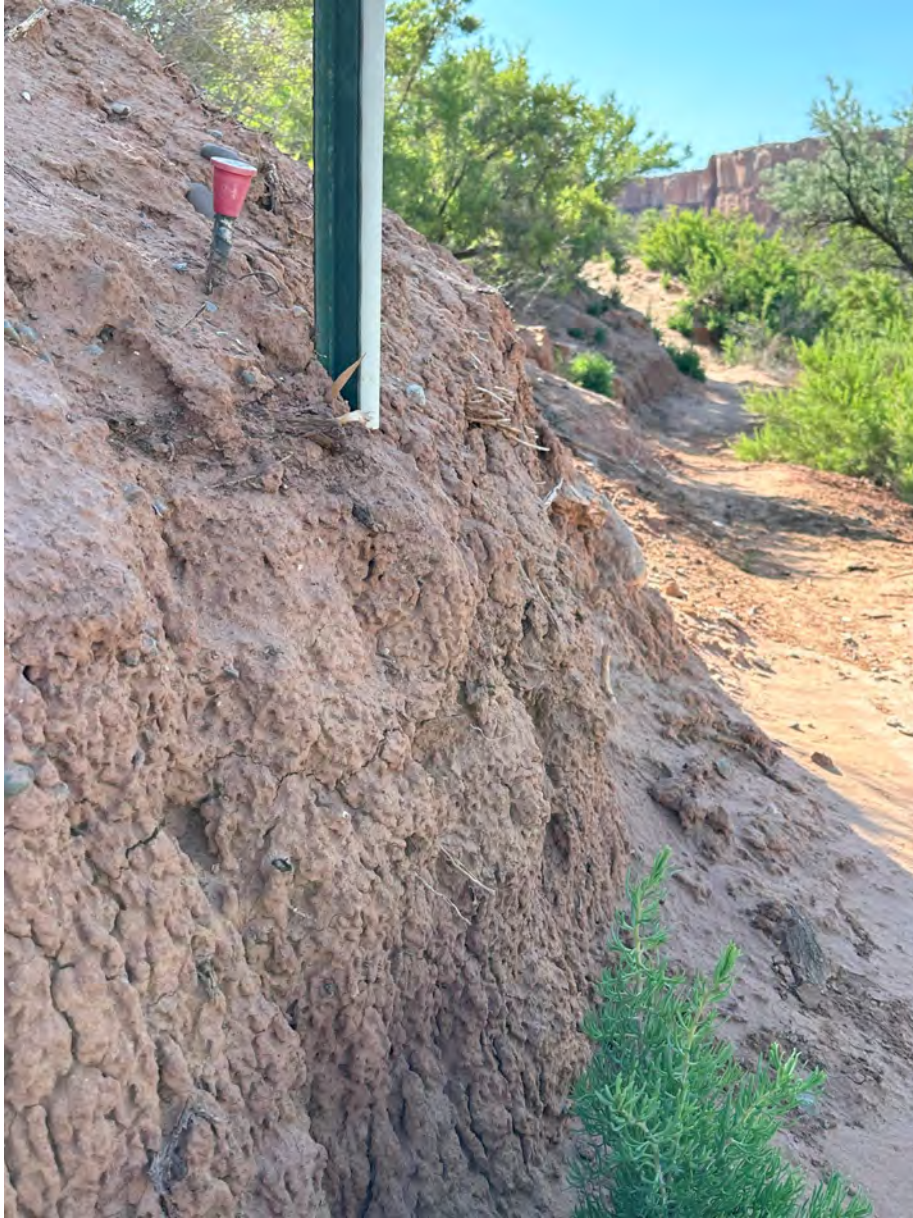
5/24/2024 (roughly 2-1/2 years after excavation)

Top of cut has eroded back, becoming more rounded, slope of cut has decreased as top has eroded back, small gullies have formed in face of cut, and sediment has accumulated on trail below cut

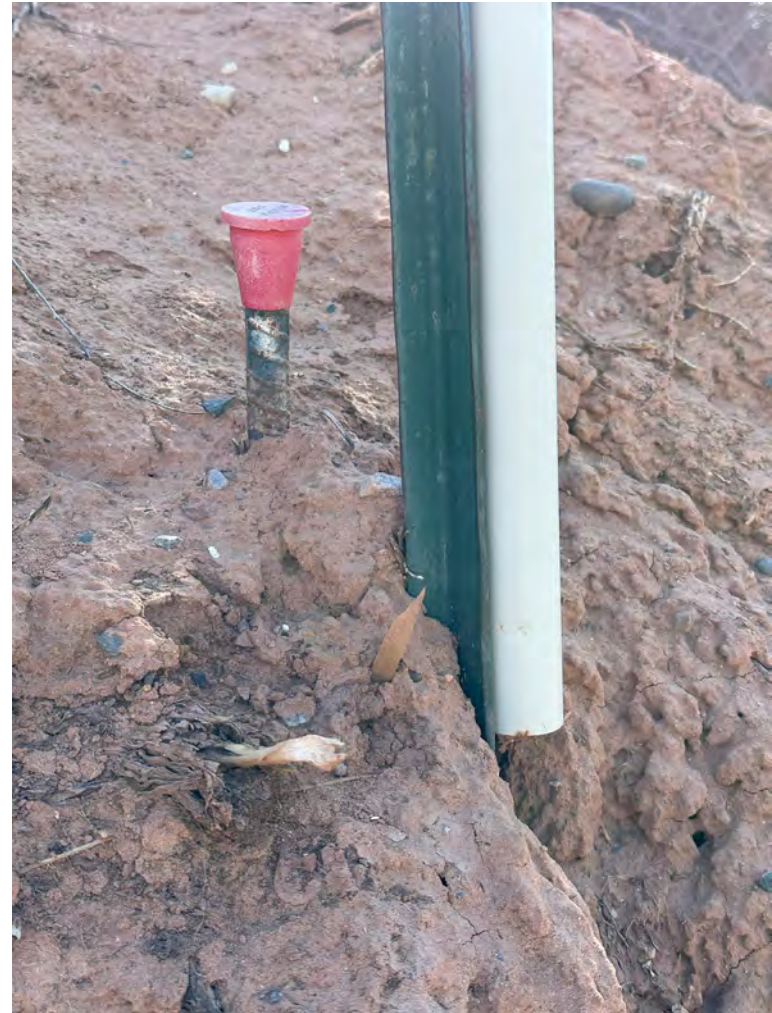
Soil on unexcavated surface above cut is now several inches below red cap on Burns SW corner pin and lower end of white marker pipe is now several inches above soil

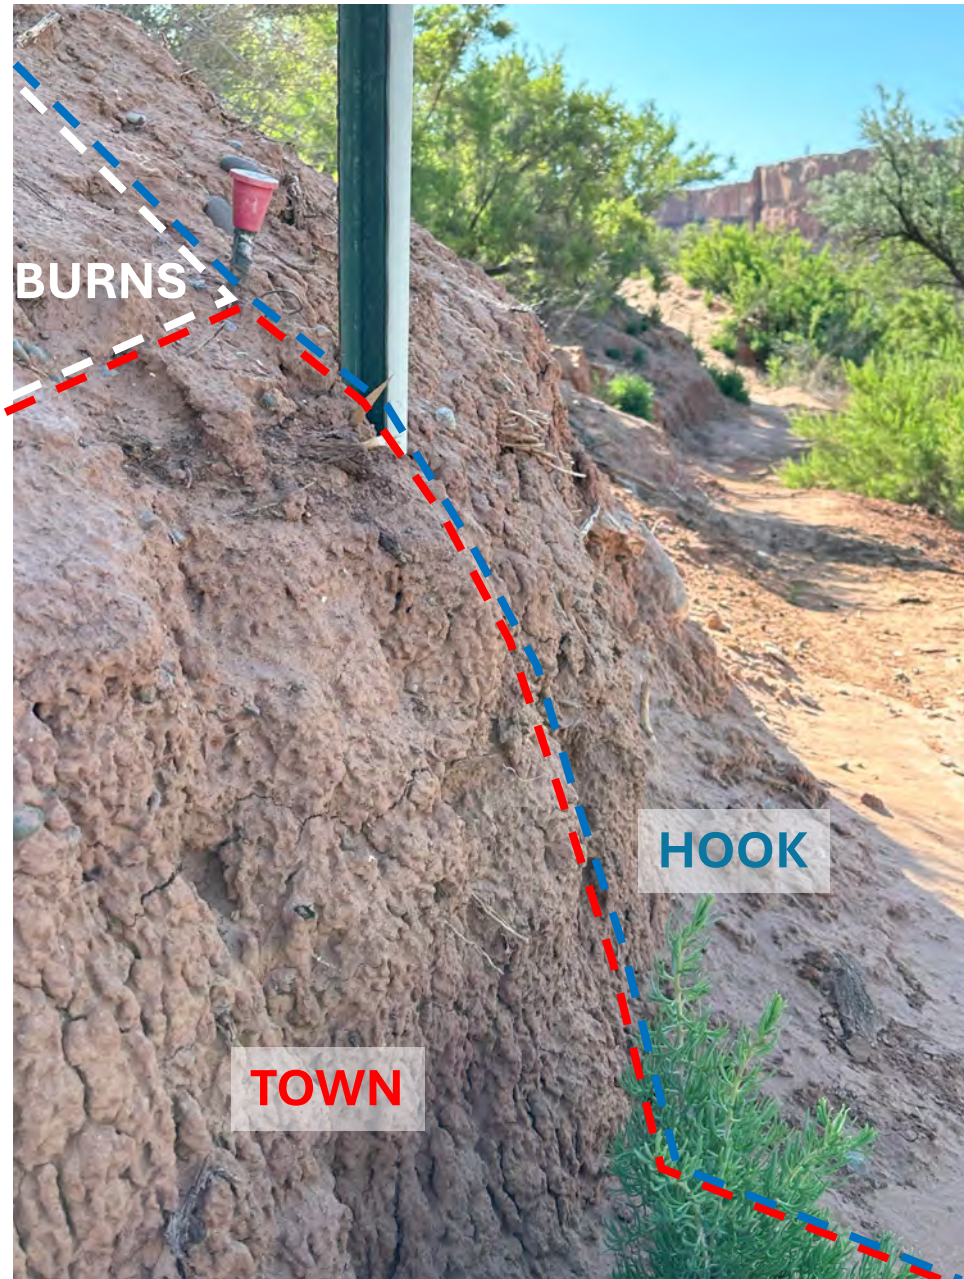
5/24/2024 (roughly 2-1/2 years after excavation)

Top of cut has eroded back and sediment has accumulated at base of cut

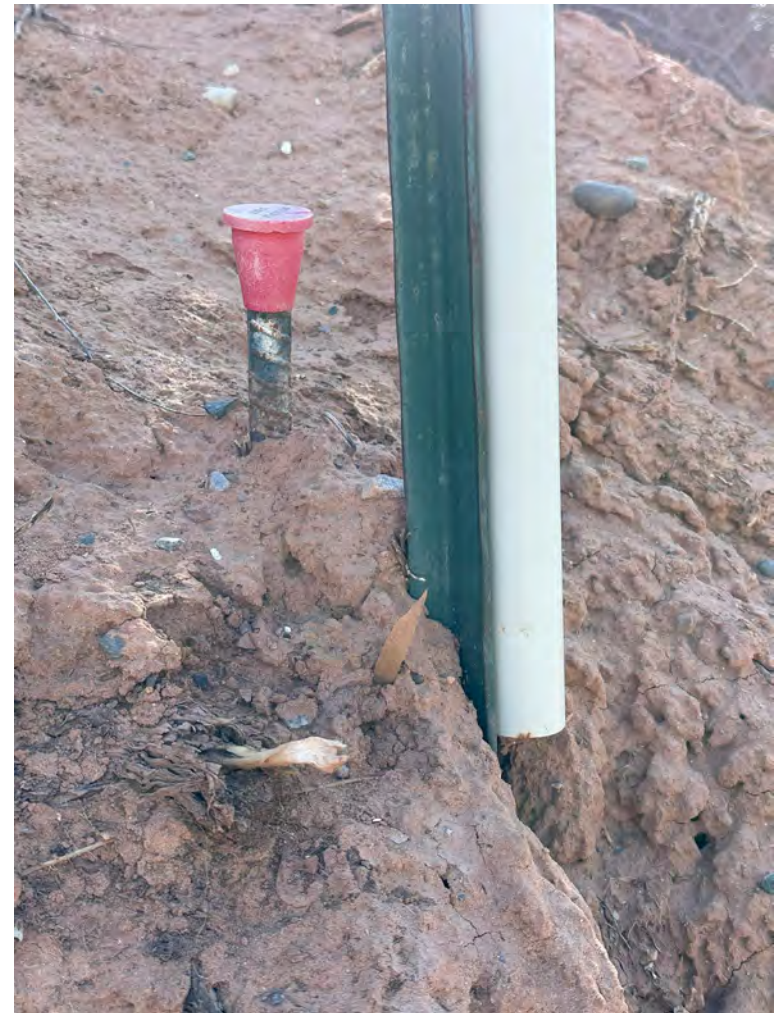
Soil is several inches below red cap on Burns SW corner pin and lower end of white pipe is several inches above soil

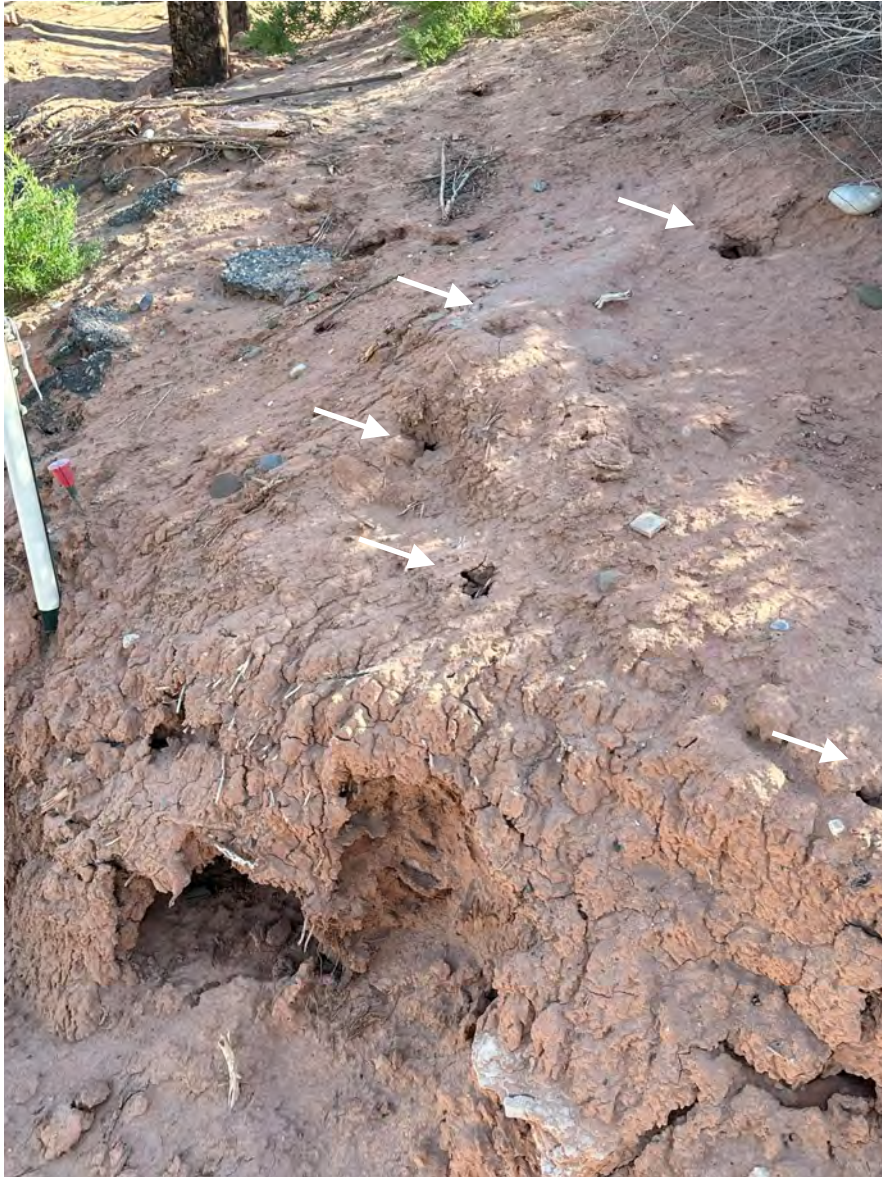
5/24/2024 (roughly 2-1/2 years after excavation)

Small openings ('swallow holes') in upper unexcavated slope are entrances to eroded pipe-like openings within sediment ('piping')

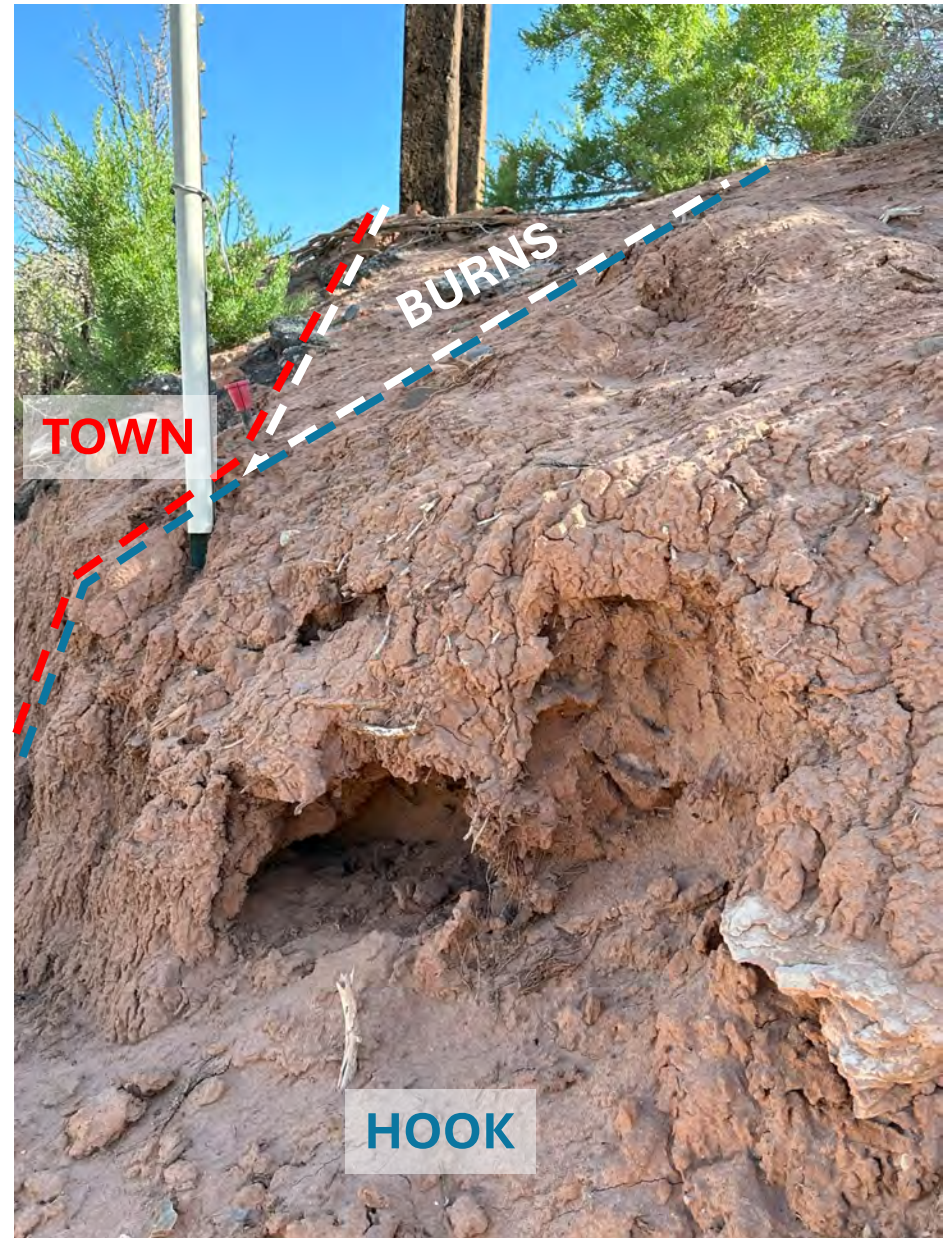
Better view of openings near base of excavated cut where moisture from pipes is exiting and depositing sediment onto trail. Eventually these openings and soil above them will collapse back to swallow holes

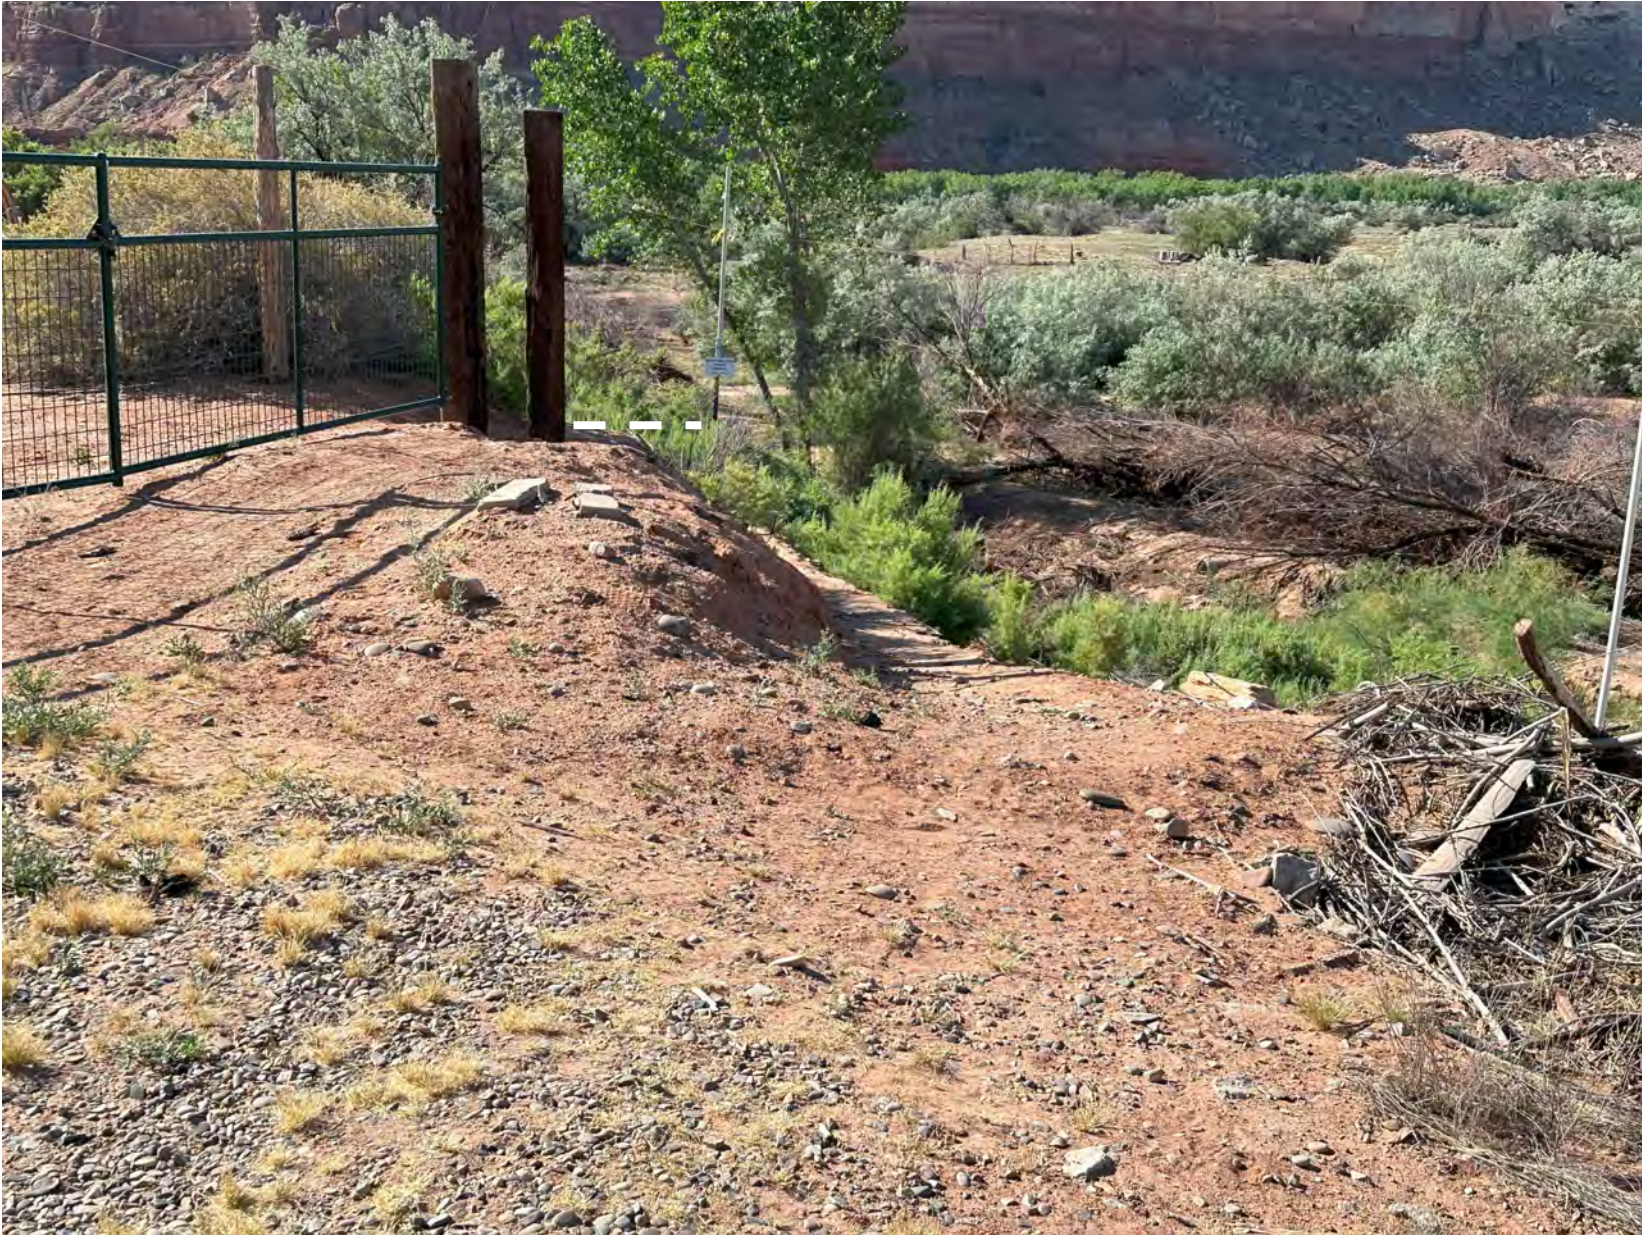
5/24/2024 (roughly 2-1/2 years after excavation)

Edges of original excavation into end of South 6th West alley softened by erosion, with cut brush dumped onto town property at right. Excavation makes it difficult for a vehicle to turn from alley through Burns gate (perhaps impossible for a longer vehicle like a pickup).

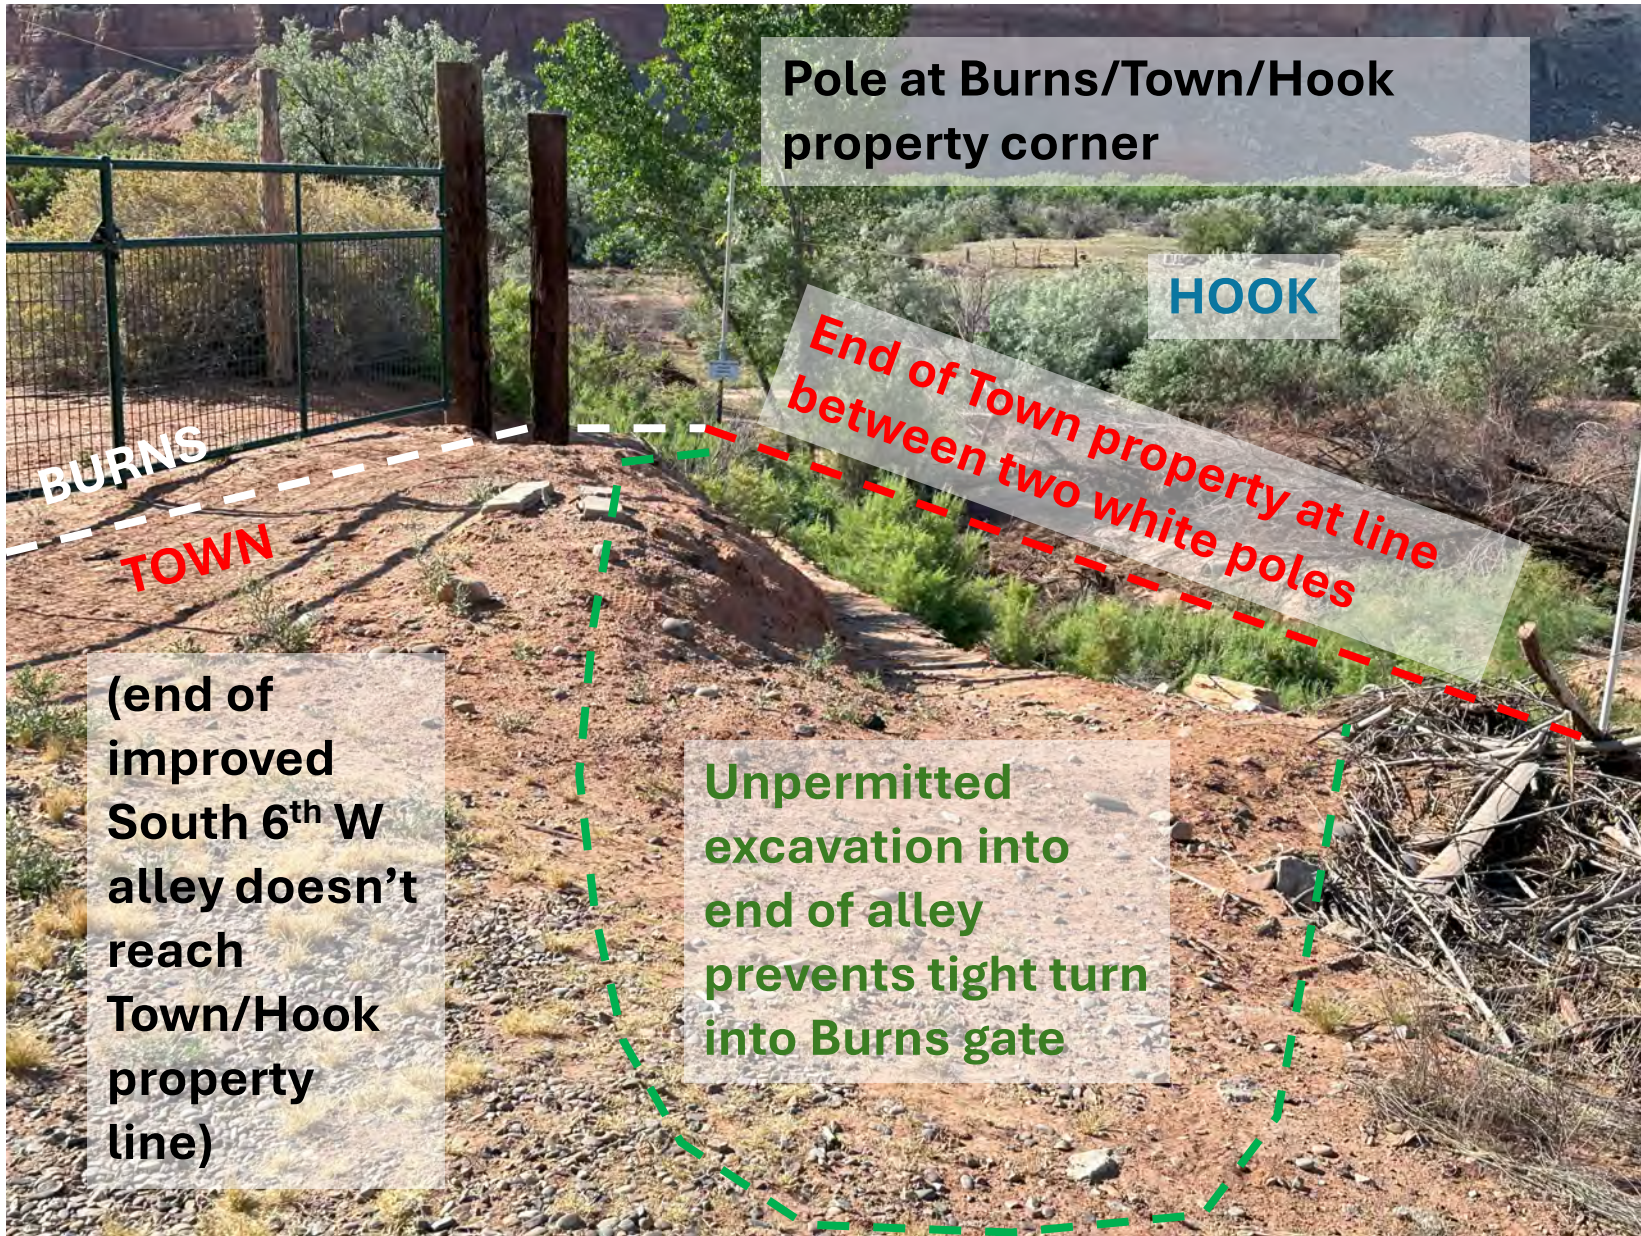
5/24/2024 (roughly 2-1/2 years after excavation)

Edges of original excavation into end of South 6th West alley softened by erosion, with cut brush dumped onto town property at right. Excavation makes it difficult for a vehicle to turn from alley through Burns gate (perhaps impossible for a longer vehicle like a pickup).
